Bill Owen  
Arborwell  
ISA Board Certified Master Arborist  
WE-7113-B  
10/25/2011

## Congregational Church of San Mateo

### Summary

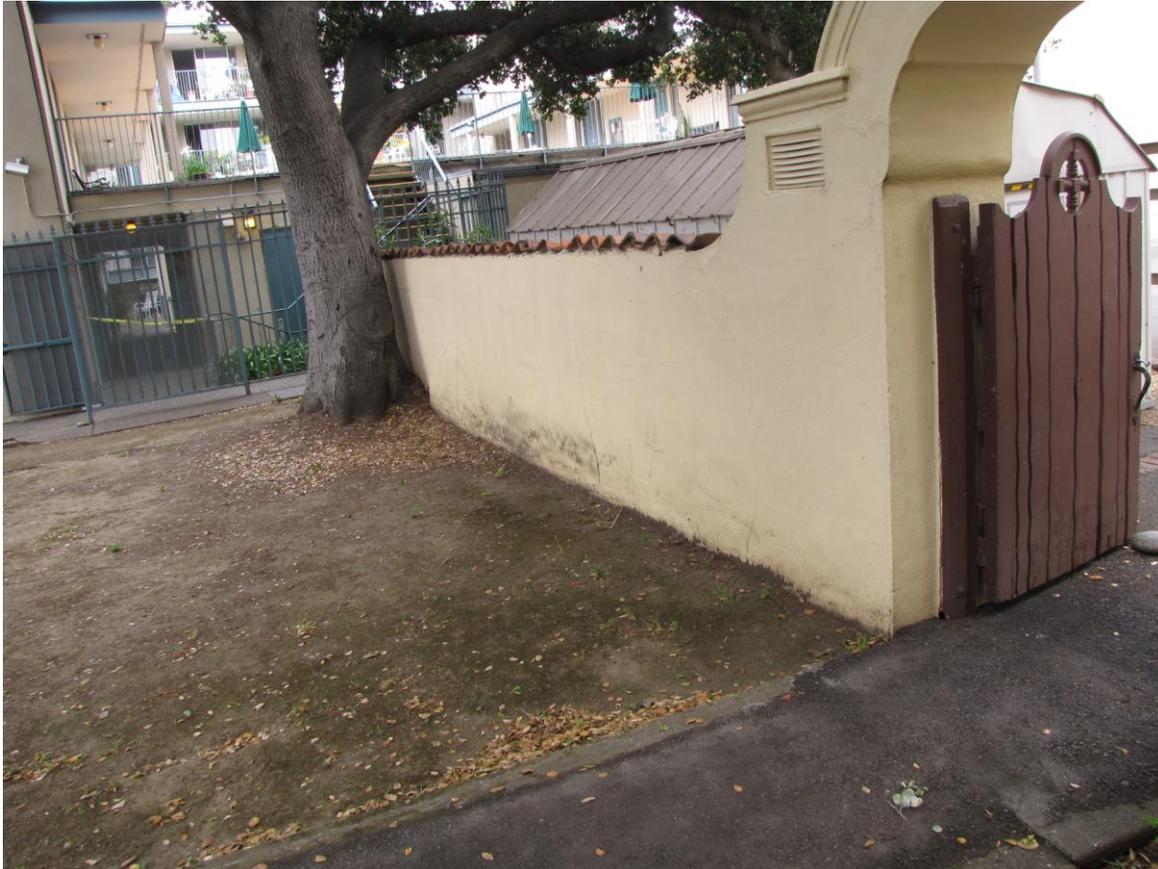
Photo 1

Photo one was taken during my site visit on June 9<sup>th</sup> and shows tree two and the existing wall that will be demolished as part of the project.

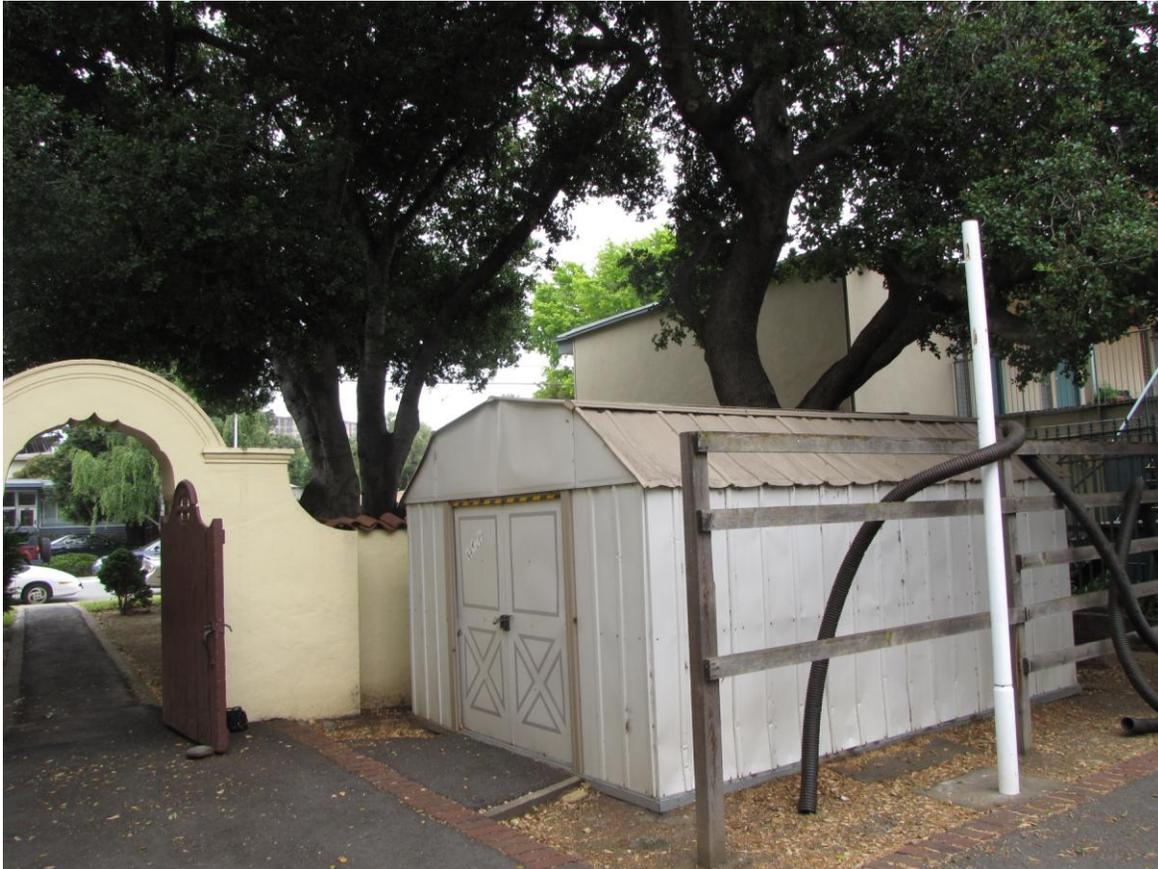
## Photo 2

I inspected the site on June 9<sup>th</sup>, and July 7<sup>th</sup> 2010. The site address is 225 Tilton Ave in San Mateo. While I was onsite I met with John Fyfe and Jim Ingwersen from the Congregational Church of San Mateo. John Cahalan, the Landscape architect was at the site meeting on July 7<sup>th</sup>. I inspected the site as it is now, prior to construction. The site consists of an open area beneath the two oaks and an existing masonry wall that will be demolished to facilitate construction. The wall runs along the edge of the trunk of tree #2(photo 1). The proposed construction will encompass portions of the root zones of the two oaks and extend in to the open asphalt area to the east of tree #2(photo 2).

Photo two was taken during my site visit on June 9<sup>th</sup> and shows the east side of tree two and the existing wall that will be demolished as part of the project behind the shed

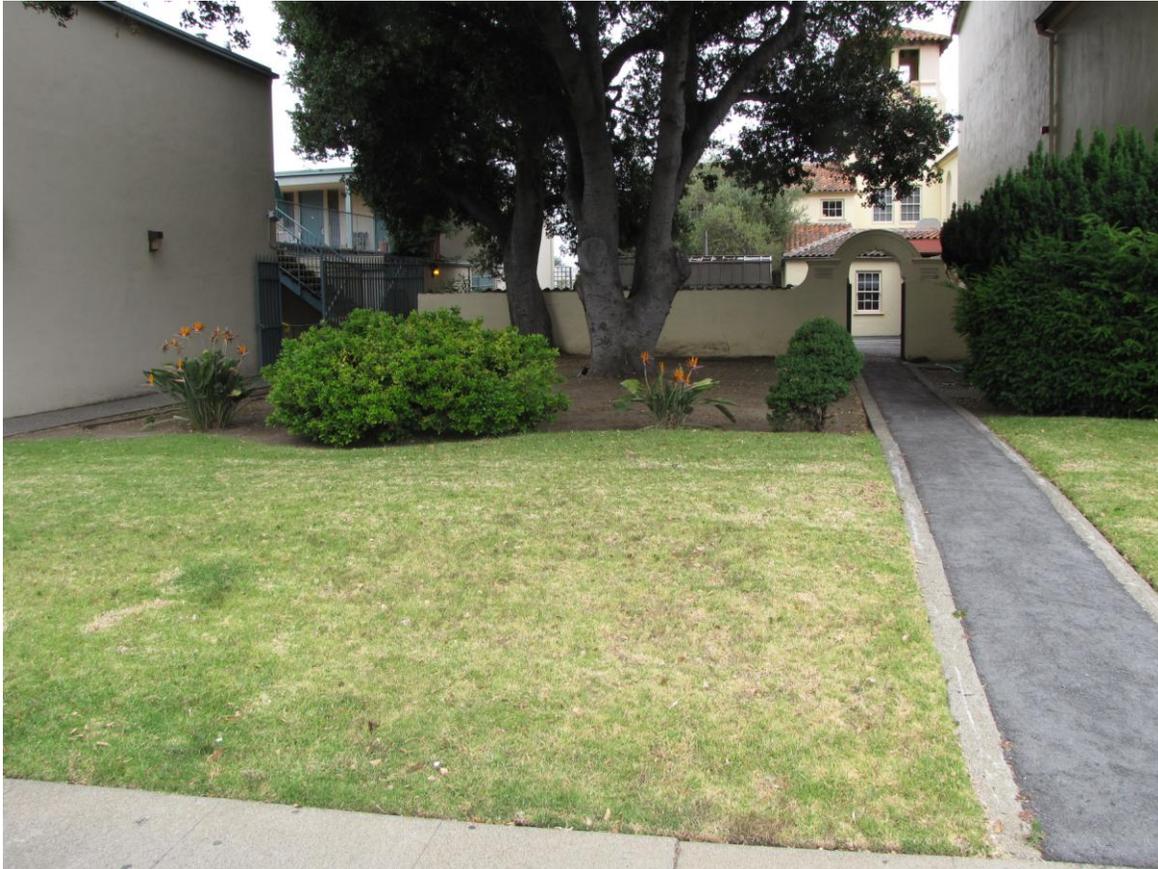
### Photo 3

The existing landscape under the two oaks is bare compacted soil with some adjacent landscape plants next to a small lawn area along the sidewalk for San Mateo Blvd (photo 3).

Photo three was taken on my site visit June 9<sup>th</sup> and shows the project site as seen from San Mateo Blvd north of Tilton Street.

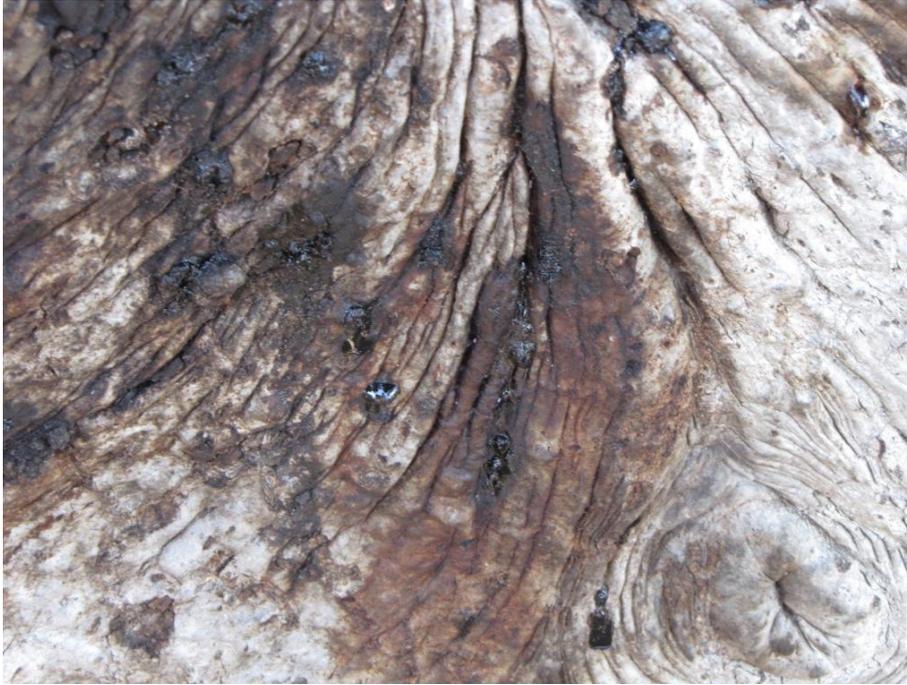
## Photo 4

Tree 1 is a coast live oak that measures approximately 40 feet tall, has a crown spread of 50 feet and has a diameter at breast height of 53 ½ inches. Leaf size is normal for the species. Annual twig extension is normal. Canopy density is medium. There are no obvious signs of decay throughout the crown. There are oozing cankers along the lower trunk of tree 1. On July 7<sup>th</sup>, I photographed the cankers and cut into the cambium to determine the pathogen. Based on a visual assessment the pathogen appeared to be some type of *Phytophthora*. The cankers on the lower trunk had a black shiny liquid oozing from various points. The cankers cover approximately 15% of the circumference of the trunk just below the first branch union. I cut into the cambium layer to investigate. (See photos 4 and 5). Tissue samples from the trunk were submitted to Soil and plant labs for analysis. The tissue sample did not isolate a specific pathogen associated with the cankers (see appendix 1).

Photo 4 shows a close up of the trunk of tree1 (taken7-7-2010).

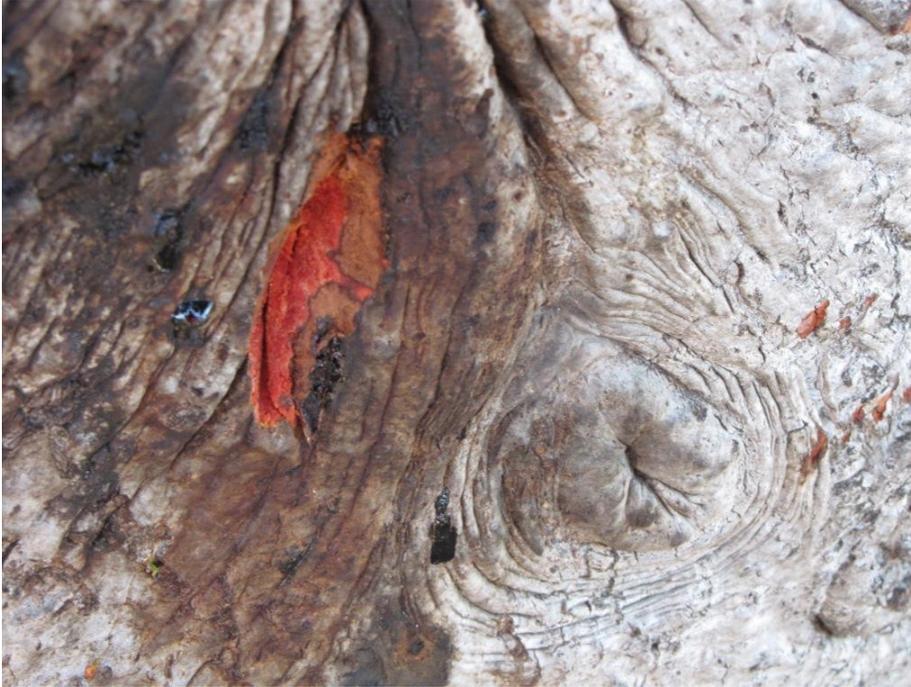
## Photo 5

Based on the lab results yielded from the tissue sample from tree one, cause of the cankers has not been determined. It is possible the cankers are caused by a non-lethal pathogen such as bacterial wet wood. Such an infection would not be a cause for concern, and would necessitate no special considerations beyond normal preservation.

The above photo shows the cambium layer of tree one after cutting through the oozing canker (taken 7-7-2010).
