RE: Building Survey Summary
Leong Family Dentistry
420 Peninsula Avenue
San Mateo, CA 94401

BUILDING CONDITION SURVEY REPORT

**PENINSULA HEALTH CENTER
420 PENINSULA AVENUE
SAN MATEO, CA**

PROFESSIONAL OFFICE CONDOMINIUM CONVERSION

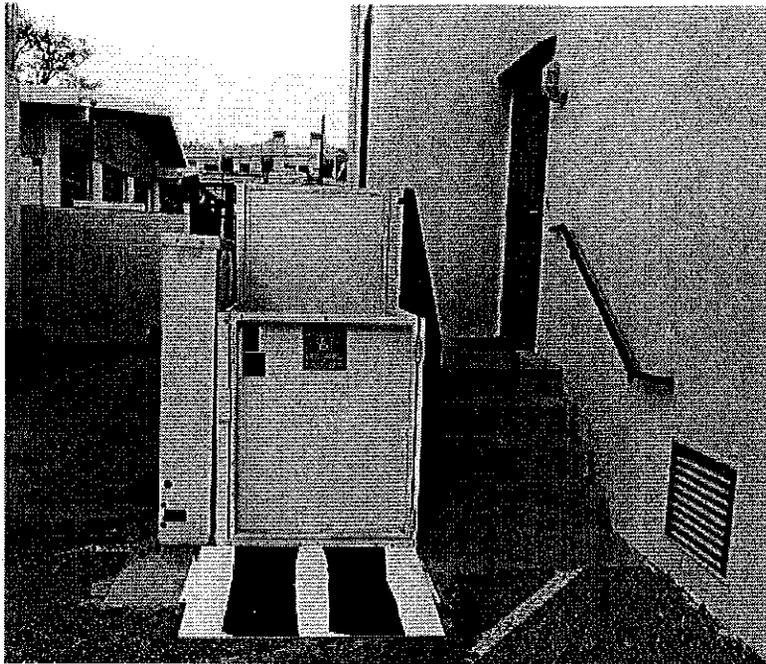
Figure 2 Wheel Chair Lift at South Exit

1. The current dental office is provided with two exits. The exit leading to the private parking lot is provided with a wheelchair lift (see Figure 2). As the dental office is classified as a Business occupancy and has an area of 1,471 square feet, a total of 15 occupants is assumed per the CBC Table 1004.1.1. Therefore, one exit is required. According to CBC Section 1007.1, at least one accessible means of egress is required to be provided. The number of exits and the number of accessible exits meet the code requirements.

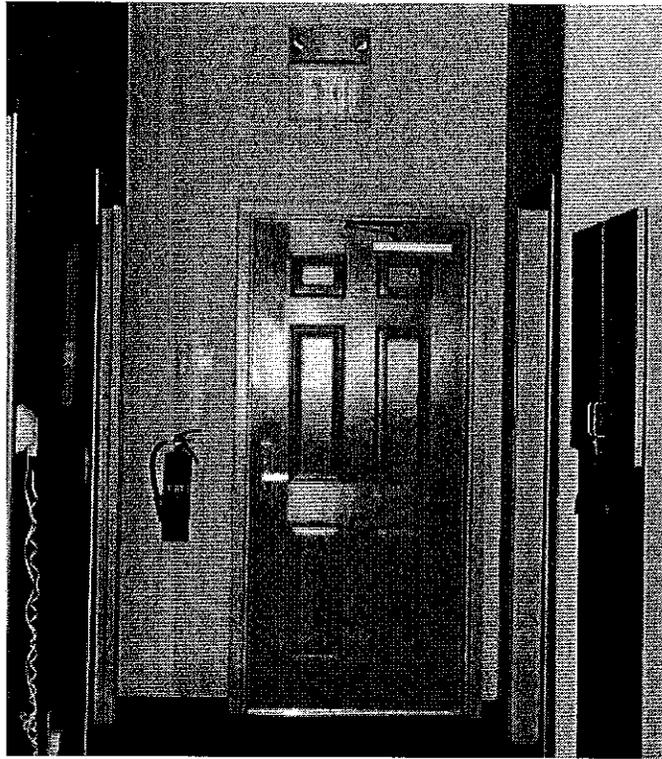
Figure 3 Exit Sign at South Exit

5. Illuminated exit signs are provided throughout the dental office (see Figure 3).
6. Emergency lighting is provided throughout the dental office. It meets the code requirements. It appears that the emergency lights are provided with battery backup power.

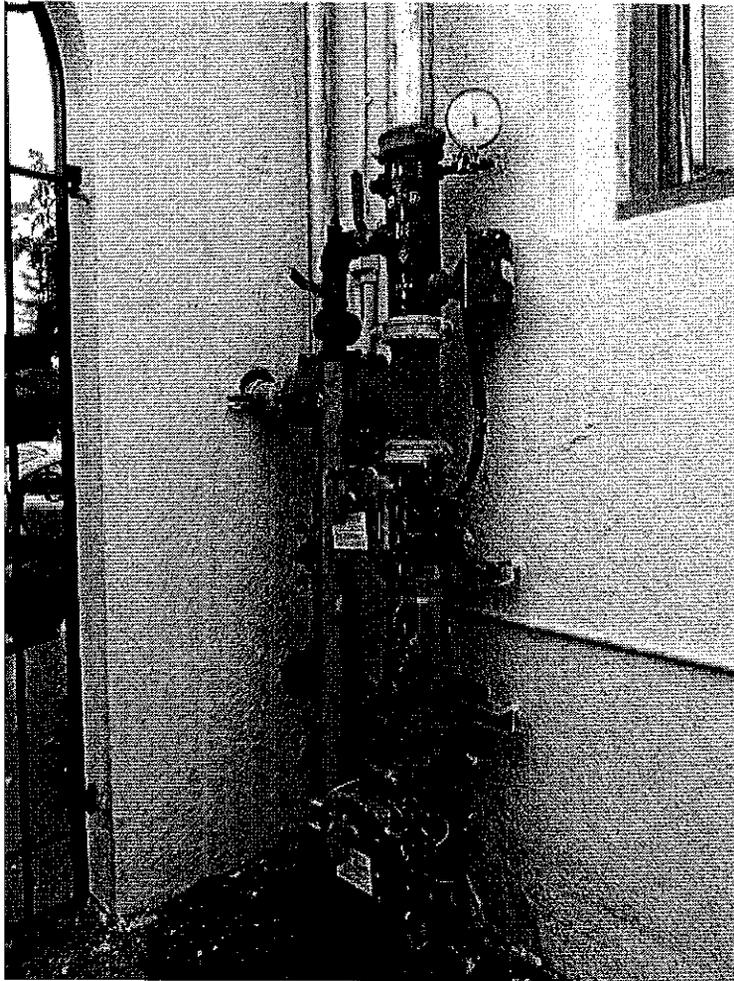
Figure 4 Existing Riser

10. The sprinkler system riser is a 3-inch riser located outside near the northwest corner of the building (see Figure 4). The sprinkler riser appears to be galvanized. It appears that the waterflow switch is electrically monitored. The two butterfly valves are not electrically monitored. They are locked in the open position. According to CBC 903.4 and NFPA 13 Section 8.16.1.1.2.1, this is considered acceptable when the system serves less than 20 sprinklers. As the vacant space of this building will be provided with sprinkler protection during renovation, the sprinkler system will serve more than 20 sprinklers. It is required that all valves controlling the water supply to be electrically supervised.

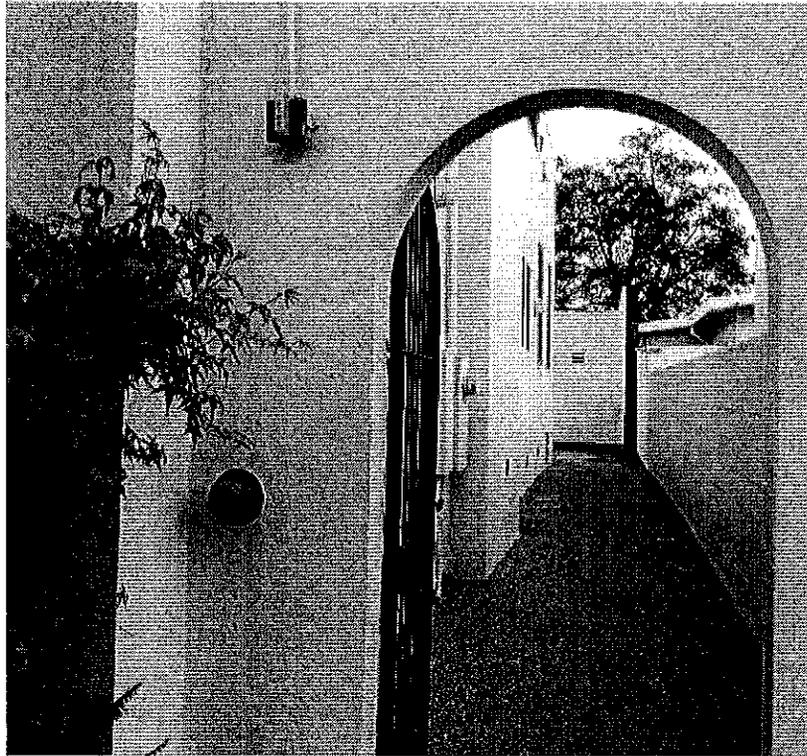
Figure 5 FDC and Alarm

11. One fire department connection (FDC) is located on the north wall of the building. A single outlet is provided (see Figure 5). As the FDC is connected to a 3-inch sprinkler riser, this is considered acceptable (NFPA 13 Section 6.8.1.3).
12. One horn/strobe alarm is provided on the north wall (see Figure 5). It meets the code requirements specified in CBC 903.4.2 for providing one exterior audible device.
13. According to NFPA 72 Section 10.15, automatic smoke detection is required if the location of the fire alarm control units and the supervising station are not continuously occupied. It is required that a smoke detector be installed at the location of the waterflow monitoring panel (i. e., fire alarm control unit).

- c. On the west side (the dental office side), the exterior wall is approximately 6.3 feet from the masonry wall along the property line (see Figure 5). According to CBC Table 602, a one-hour rated exterior wall is required, assuming the building is fully sprinklered. The area of unprotected openings in the exterior wall can be up to 25 percent of the wall area per Table 705.8. There is a gas station located on the adjacent property, beyond the masonry wall. The individual fueling stations are approximately 30 feet away from the property line. The gas station is located on a corner lot that is open to Peninsula Avenue and Woodside Way. It is assumed that the subject building's exterior wall on the west side is the original construction and is not fire rated. As no major construction will be planned for the newly remodeled dental office, we suggest that no action is required to upgrade the existing noncompliant exterior wall on the west side of the building during the proposed renovation.

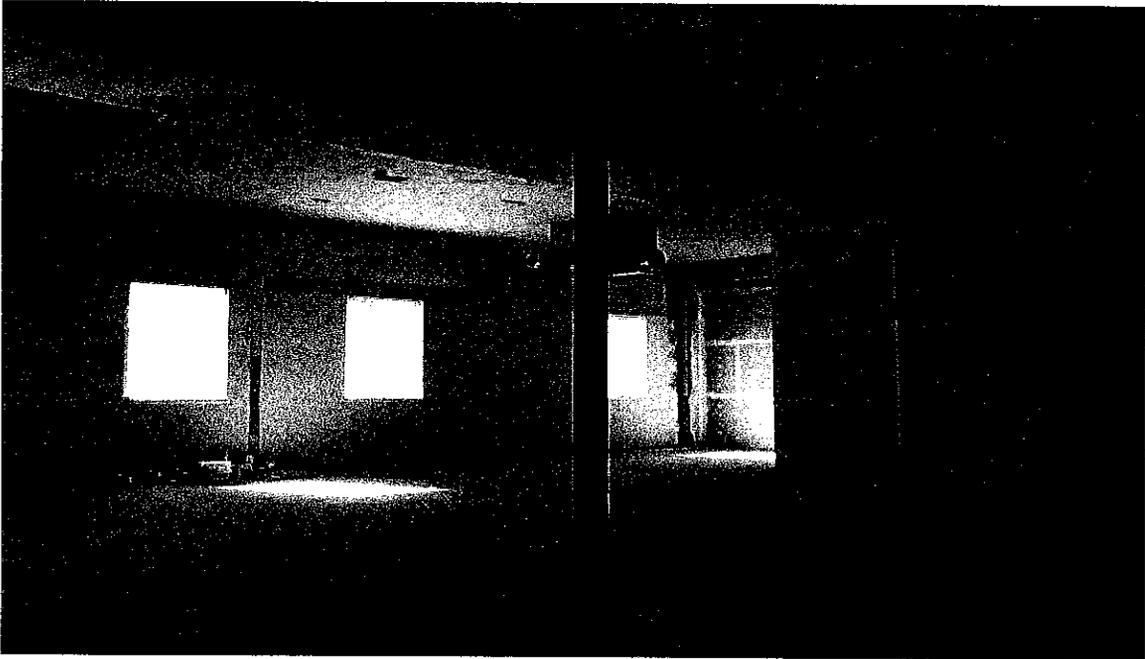
STRUCTURAL IMPROVEMENTS IN THE VACANT SPACE

Our visual inspection of the building has concluded that it is in very good overall condition and structurally sound. Buildings of this age with old growth lumber are particularly strong, unless compromised by deteriorating structural members, which was addressed during the remodel with a new glu-lam beam and new support columns in the vacant space.
