# WOOD DESTROYING PESTS AND ORGANISMS INSPECTION REPORT

Building No. 420	Street PENINSULA AVE.	City SAN MATEO	Zip 94401	Date of Inspection 12/16/13	Number of Pages 5
---------------------	--------------------------	-------------------	--------------	--------------------------------	----------------------

Report #: 32054

CORRECTED REPORT

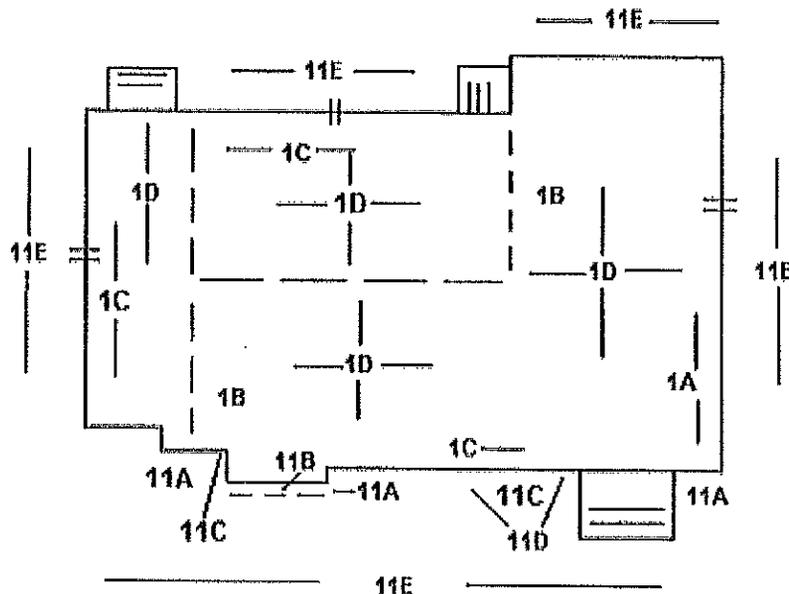
Diagram Not To Scale

01A - FINDING-OLD SUBTERRANEAN TERMITE DAMAGE NOTED AT RIM JOIST, SUBFLOOR AS INDICATED BY 1A ON THE DIAGRAM.

01B - FINDING-CELLULOSE DEBRIS NOTED AT AS MARKED ON DIAGRAM AS INDICATED BY 1B ON THE DIAGRAM.

01C - FINDING-MOISTURE STAIN NOTED AT MUDSILL AS INDICATED BY 1C ON THE DIAGRAM.

01D - FINDING-INACCESSIBLE AREAS NOTED AT DUE TO SUBFLOOR INSULATION AS INDICATED BY 1D ON THE DIAGRAM.

11A - FINDING-INACCESSIBLE AREAS NOTED AT DUE TO FOLIAGE AS INDICATED BY 11A ON THE DIAGRAM.

11B - FINDING-FUNGUS AND DRY ROT NOTED AT PLANT PLATFORM AS INDICATED BY 11B ON THE DIAGRAM.

11C - FINDING-FUNGUS AND DRY ROT NOTED AT WINDOW TRIM AS INDICATED BY 11C ON THE DIAGRAM.

11D - FINDING-FUNGUS AND DRY ROT NOTED AT ROOF TRIM BAND AS INDICATED BY 11D ON THE DIAGRAM.

11E - FINDING- SIDING EMBEDDED INTO EXTERIOR GRADE NOTED AT STUCCO BELOW GRADE AS INDICATED BY 11E ON THE DIAGRAM.

RECOMMENDATION: THIS HOME WAS CONSTRUCTED WITHOUT THE USE OF A WEEP SCREED AT THE BASE OF THE STUCCO. ALTHOUGH THIS WAS AN ACCEPTED CONSTRUCTION METHOD IT DOES CREATE AN AREA THAT CAN ALLOW SUBTERRANEAN TERMITES TO ACCESS THE HOME WITHOUT BEING DETECTED. THIS AREA CAN ALSO ALLOW CONDENSATION TO BUILD UP AND NOT DRAIN PROPERLY. THERE IS NO EVIDENCE OF ANY ADVERSE CONDITION AT THIS TIME HOWEVER IF FURTHER INFORMATION IS DESIRED IT WILL BE NECESSARY TO INSTALL A SERIES OF TEST HOLES TO ALLOW FOR FURTHER INSPECTION. ALL FINDINGS/RECOMMENDATIONS AND BIDS WILL BE ISSUED IN A SUPPLEMENTAL REPORT.

RECOMMENDATION: OWNER AND/OR OWNER'S LICENSED CONTRACTOR TO REMOVE AND REPLACE ACCESSIBLE SUBTERRANEAN TERMITE DAMAGED WOOD AS NECESSARY. PRIME AREA FOR PAINTING. IF DAMAGE EXTENDS INTO INACCESSIBLE AREA(S), HI TECH TERMITE CONTROL OF THE BAY AREA WILL SUBMIT A SUPPLEMENTAL REPORT AND BID IF NECESSARY. HI TECH TERMITE CONTROL OF THE BAY AREA IS NOT RESPONSIBLE FOR WORK PERFORMED BY OTHERS.  
SECTION 1

RECOMMENDATION: OWNER TO REMOVE CELLULOSE DEBRIS FROM PROPERTY.  
SECTION 2

RECOMMENDATION: OWNER OR OWNER'S LICENSED CONTRACTOR TO CORRECT MOISTURE CONDITION AND/OR PRIME AND PAINT AREA TO CORRECT. IF DAMAGE EXTENDS INTO INACCESSIBLE AREA(S) HI TECH TERMITE CONTROL OF THE BAY AREA WILL SUBMIT A SUPPLEMENTAL REPORT AND/OR BID IF NECESSARY. HI TECH TERMITE CONTROL OF THE BAY AREA IS NOT RESPONSIBLE FOR THE WORK OF OTHERS.  
SECTION 2

RECOMMENDATION: HI TECH TERMITE CONTROL OF THE BAY AREA RECOMMENDS FURTHER INSPECTION.  
UNKNOWN-FURTHER INSPECTION

RECOMMENDATION: OWNER AND/OR LICENSED CONTRACTOR TO CORRECT FUNGUS CONDITION AND/OR REMOVE AND REPLACE ACCESSIBLE FUNGUS AND DRY ROT DAMAGED WOOD AND/OR MATERIALS, TREAT AREA WITH STATE REGISTERED FUNGICIDE AND PRIME AND PAINT AREA TO CORRECT. IF DAMAGE EXTENDS INTO INACCESSIBLE AREA(S) HI TECH TERMITE CONTROL OF THE BAY AREA WILL SUBMIT A SUPPLEMENTAL REPORT AND/OR BID IF NECESSARY, HI TECH TERMITE CONTROL OF THE BAY AREA IS NOT RESPONSIBLE FOR WORK PERFORMED BY OTHERS.  
SECTION 1

RECOMMENDATION: OWNER AND/OR LICENSED CONTRACTOR TO CORRECT FUNGUS CONDITION AND/OR REMOVE AND REPLACE ACCESSIBLE FUNGUS AND DRY ROT DAMAGED WOOD AND/OR MATERIALS, TREAT AREA WITH STATE REGISTERED FUNGICIDE AND

PRIME AND PAINT AREA TO CORRECT. IF DAMAGE EXTENDS INTO INACCESSIBLE AREA(S) HI TECH TERMITE CONTROL OF THE BAY AREA WILL SUBMIT A SUPPLEMENTAL REPORT AND/OR BID IF NECESSARY. HI TECH TERMITE CONTROL OF THE BAY AREA IS NOT RESPONSIBLE FOR WORK PERFORMED BY OTHERS.

RECOMMENDATION: OWNER AND/OR LICENSED CONTRACTOR TO CORRECT FUNGUS CONDITION AND/OR REMOVE AND REPLACE ACCESSIBLE FUNGUS AND DRY ROT DAMAGED WOOD AND/OR MATERIALS, TREAT AREA WITH STATE REGISTERED FUNGICIDE AND PRIME AND PAINT AREA TO CORRECT. IF DAMAGE EXTENDS INTO INACCESSIBLE AREA(S) HI TECH TERMITE CONTROL OF THE BAY AREA WILL SUBMIT A SUPPLEMENTAL REPORT AND/OR BID IF NECESSARY. HI TECH TERMITE CONTROL OF THE BAY AREA IS NOT RESPONSIBLE FOR WORK PERFORMED BY OTHERS.

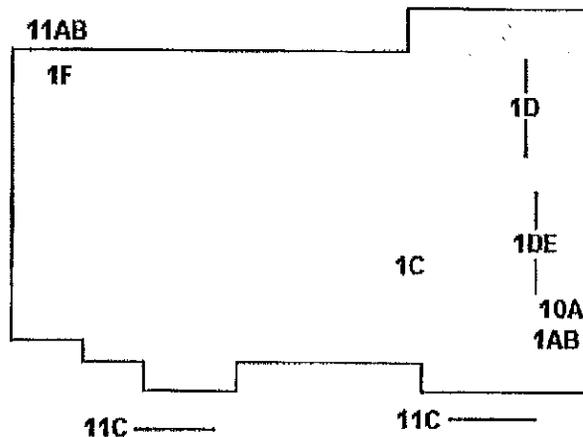
Diagram Not To Scale

01A - FINDING-EVIDENCE OF SUBTERRANEAN TERMITES NOTED AT SUBFLOOR AS INDICATED BY 1A ON THE DIAGRAM.

01B - FINDING-SUBTERRANEAN TERMITE DAMAGE NOTED AT SUBFLOOR AS INDICATED BY 1B ON THE DIAGRAM.

01C - FINDING-EVIDENCE OF SUBTERRANEAN TERMITES NOTED AT SOIL AS INDICATED BY 1C ON THE DIAGRAM.

01D - FINDING-MOISTURE STAIN NOTED AT THROUGHOUT MUDSILL/SUBFLOOR AS INDICATED BY 1D ON THE DIAGRAM.

01E - FINDING-CELLULOSE DEBRIS NOTED AT SOIL AS INDICATED BY 1E ON THE DIAGRAM.

01F - FINDING-EVIDENCE OF DRYWOOD TERMITE INFESTATION WHICH APPEARS TO BE LEADING INTO WALL VOID(S) NOTED AT MUDSILL WALL AS INDICATED BY 1F ON THE DIAGRAM.

10A - FINDING-EVIDENCE OF DRYWOOD TERMITE INFESTATION WHICH APPEARS TO BE LEADING INTO WALL VOID(S) NOTED AT FRONT WINDOW/WALL AS INDICATED BY 10A ON THE DIAGRAM.

11A - FINDING-EVIDENCE OF DRYWOOD TERMITE INFESTATION WHICH APPEARS TO BE LEADING INTO WALL VOID(S) NOTED AT BACK THRESHOLD AS INDICATED BY 11A ON THE DIAGRAM.

11B - FINDING-FUNGUS AND DRY ROT NOTED AT BACK THRESHOLD AS INDICATED BY 11B ON THE DIAGRAM.

11C - FINDING-INACCESSIBLE AREAS NOTED AT FRONT EXTERIOR DUE TO SHRUBS AS INDICATED BY 11C ON THE DIAGRAM.

RECOMMENDATION: TRENCH AND TREAT AREA WITH STATE REGISTERED CHEMICAL TERMIDOR (FIPRONIL) FOR THE CONTROL OF SUBTERRANEAN TERMITES. REMOVE ALL ACCESSIBLE TERMITE TUBING. AREA MUST BE VACATED AT TIME OF APPLICATION.  
SECTION 1

RECOMMENDATION: OWNER AND/OR OWNER'S LICENSED CONTRACTOR TO REMOVE AND REPLACE ACCESSIBLE SUBTERRANEAN TERMITE DAMAGED WOOD AS NECESSARY. PRIME AREA FOR PAINTING. IF DAMAGE EXTENDS INTO INACCESSIBLE AREA(S), HI TECH TERMITE CONTROL OF THE BAY AREA WILL SUBMIT A SUPPLEMENTAL REPORT AND BID IF NECESSARY. HI TECH TERMITE CONTROL OF THE BAY AREA IS NOT RESPONSIBLE FOR WORK PERFORMED BY OTHERS.  
SECTION 1

RECOMMENDATION: OWNER OR OWNER'S LICENSED CONTRACTOR TO CORRECT MOISTURE CONDITION AND/OR PRIME AND PAINT AREA TO CORRECT. IF DAMAGE EXTENDS INTO INACCESSIBLE AREA(S) HI TECH TERMITE CONTROL OF THE BAY AREA WILL SUBMIT A SUPPLEMENTAL REPORT AND/OR BID IF NECESSARY. HI TECH TERMITE CONTROL OF THE BAY AREA IS NOT RESPONSIBLE FOR THE WORK OF OTHERS.  
SECTION 2

RECOMMENDATION: OWNER TO REMOVE CELLULOSE DEBRIS FROM PROPERTY.  
SECTION 2

RECOMMENDATION-PRIMARY: VACATE PREMISES AND SEAL STRUCTURE. FUMIGATE WITH A LETHAL GAS (SULFURYL FLUORIDE). REMOVE THE SEALS AND AIR OUT BUILDING. MAKE READY FOR OCCUPANCY. COVER AND/OR REMOVE EVIDENCE. AREA MUST BE VACATED AT TIME OF APPLICATION.

RECOMMENDATION: OWNER AND/OR LICENSED CONTRACTOR TO CORRECT FUNGUS CONDITION AND/OR REMOVE AND REPLACE ACCESSIBLE FUNGUS AND DRY ROT DAMAGED WOOD AND/OR MATERIALS, TREAT AREA WITH STATE REGISTERED FUNGICIDE AND PRIME AND PAINT AREA TO CORRECT. IF DAMAGE EXTENDS INTO INACCESSIBLE AREA(S) HI TECH TERMITE CONTROL OF THE BAY AREA WILL SUBMIT A SUPPLEMENTAL REPORT AND/OR BID IF NECESSARY, HI TECH TERMITE CONTROL OF THE BAY AREA IS NOT RESPONSIBLE FOR WORK PERFORMED BY OTHERS.  
SECTION 1

RECOMMENDATION: HI TECH TERMITE CONTROL OF THE BAY AREA RECOMMENDS FURTHER INSPECTION.  
INFORMATIONAL ITEM
