Mr. Roland Leong, D.D.S.
Leong Family Dentistry
420 Peninsula Avenue
San Mateo, CA 94401

RE: Building Survey Summary
Leong Family Dentistry
420 Peninsula Avenue
San Mateo, CA 94401

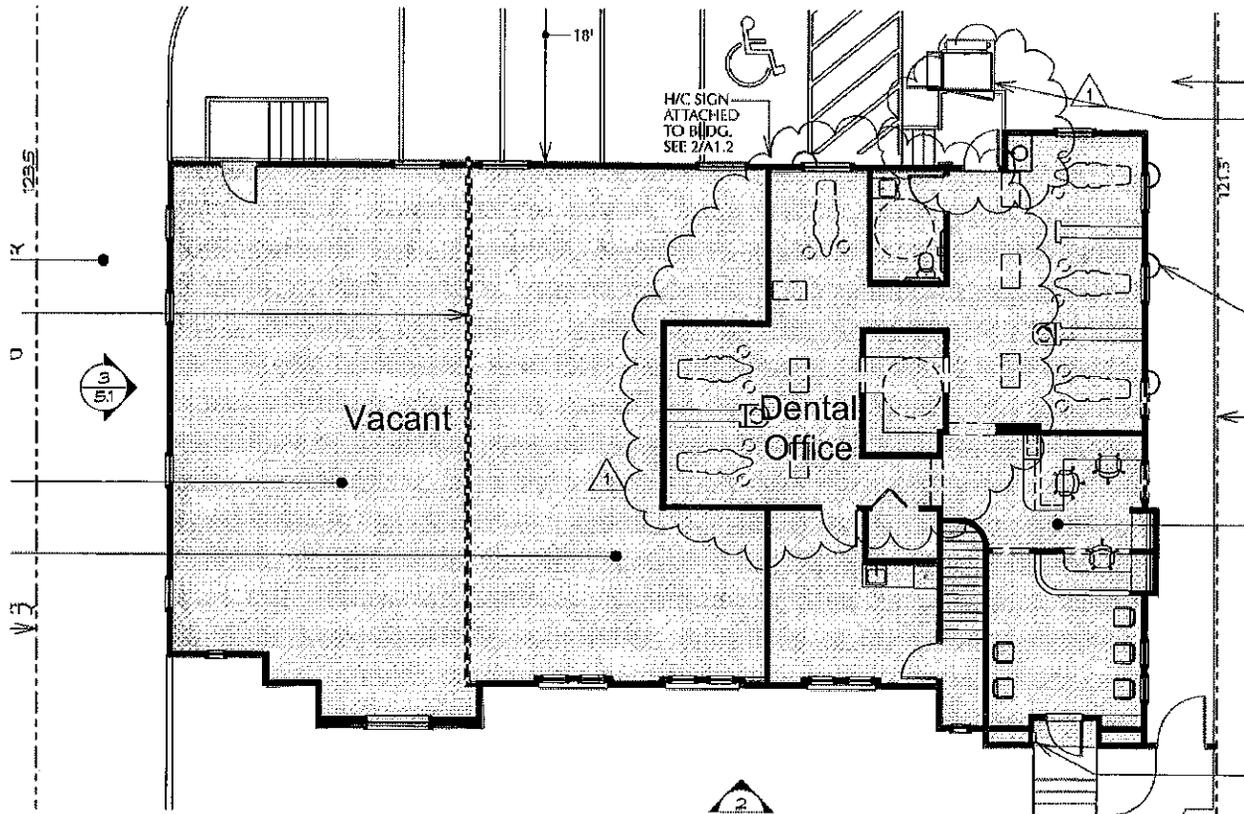
Figure 1 Building Floor Plan

The building was originally constructed in the 1920s. It is a one-story, type V non-rated building with a total area of 3,396 square feet. The building has been owned by Mr. Leong since 2003. In 2005, a portion of the building (1,471 square feet) was renovated to be used as Leong Dentistry's office. At the time of this survey, the remaining 1,925 square feet of space remained vacant (see Figure 1). According to the building owner, the vacant space will be renovated to office space.

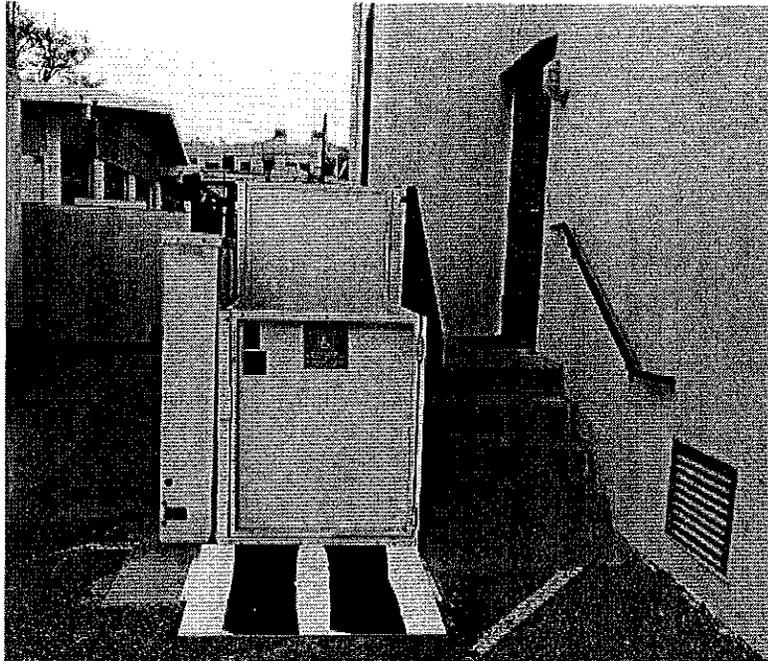
Figure 2 Wheel Chair Lift at South Exit

1. The current dental office is provided with two exits. The exit leading to the private parking lot is provided with a wheelchair lift (see Figure 2). As the dental office is classified as a Business occupancy and has an area of 1, 471 square feet, a total of 15 occupants is assumed per the CBC Table 1004.1.1. Therefore, one exit is required. According to CBC Section 1007.1, at least one accessible means of egress is required to be provided. The number of exits and the number of accessible exits meet the code requirements.

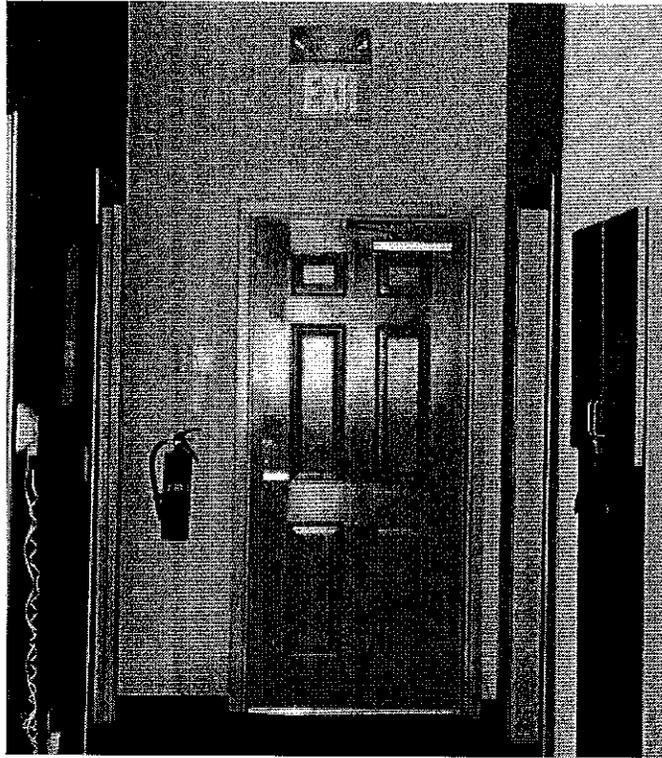
Figure 3 Exit Sign at South Exit

5. Illuminated exit signs are provided throughout the dental office (see Figure 3).
6. Emergency lighting is provided throughout the dental office. It meets the code requirements. It appears that the emergency lights are provided with battery backup power.

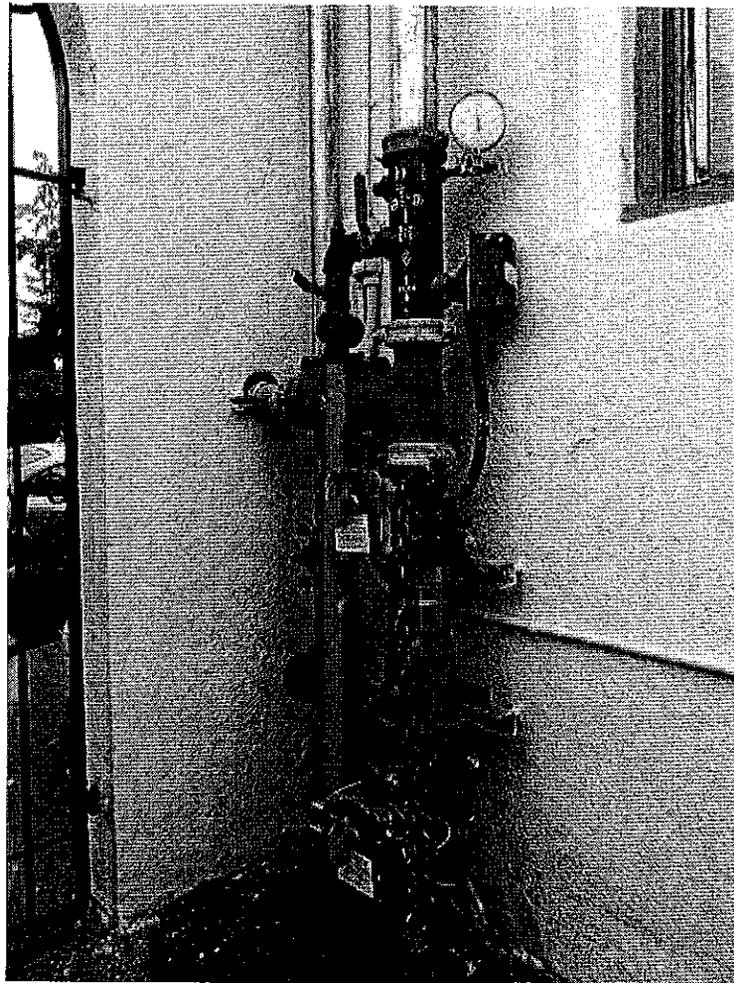
Figure 4 Existing Riser

10. The sprinkler system riser is a 3-inch riser located outside near the northwest corner of the building (see Figure 4). The sprinkler riser appears to be galvanized. It appears that the waterflow switch is electrically monitored. The two butterfly valves are not electrically monitored. They are locked in the open position. According to CBC 903.4 and NFPA 13 Section 8.16.1.1.2.1, this is considered acceptable when the system serves less than 20 sprinklers. As the vacant space of this building will be provided with sprinkler protection during renovation, the sprinkler system will serve more than 20 sprinklers. It is required that all valves controlling the water supply to be electrically supervised.

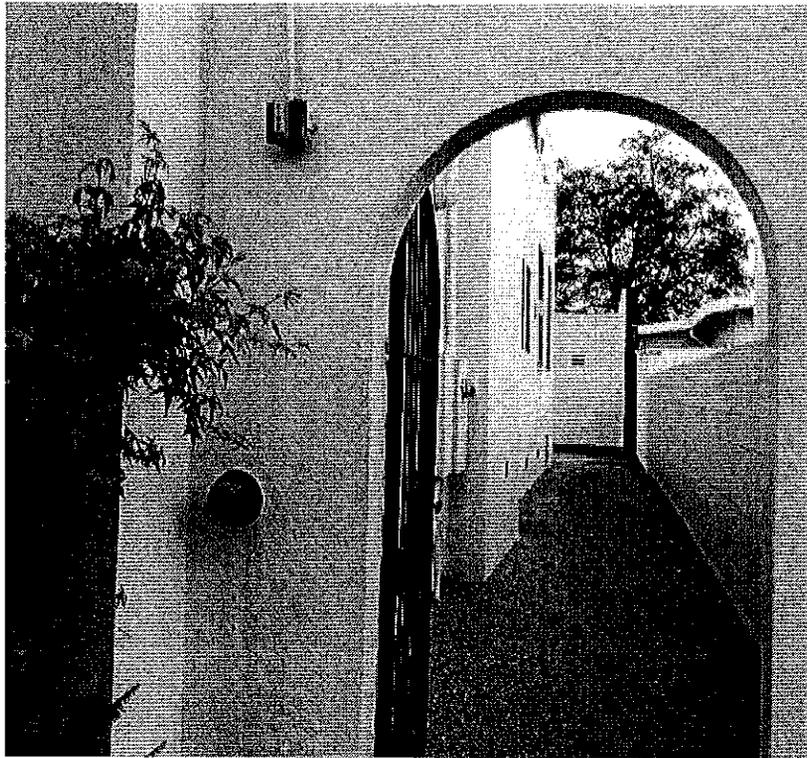
Figure 5 FDC and Alarm

11. One fire department connection (FDC) is located on the north wall of the building. A single outlet is provided (see Figure 5). As the FDC is connected to a 3-inch sprinkler riser, this is considered acceptable (NFPA 13 Section 6.8.1.3).
12. One horn/strobe alarm is provided on the north wall (see Figure 5). It meets the code requirements specified in CBC 903.4.2 for providing one exterior audible device.
13. According to NFPA 72 Section 10.15, automatic smoke detection is required if the location of the fire alarm control units and the supervising station are not continuously occupied. It is required that a smoke detector be installed at the location of the waterflow monitoring panel (i. e., fire alarm control unit).

- c. On the west side (the dental office side), the exterior wall is approximately 6.3 feet from the masonry wall along the property line (see Figure 5). According to CBC Table 602, a one-hour rated exterior wall is required, assuming the building is fully sprinklered. The area of unprotected openings in the exterior wall can be up to 25 percent of the wall area per Table 705.8. There is a gas station located on the adjacent property, beyond the masonry wall. The individual fueling stations are approximately 30 feet away from the property line. The gas station is located on a corner lot that is open to Peninsula Avenue and Woodside Way. It is assumed that the subject building's exterior wall on the west side is the original construction and is not fire rated. As no major construction will be planned for the newly remodeled dental office, we suggest that no action is required to upgrade the existing noncompliant exterior wall on the west side of the building during the proposed renovation.
