Project: 106-120 Tilton Avenue Historical Evaluation Update - Final

Date: March 28, 2014

Re: 106-120 Tilton Avenue, San Mateo, CA

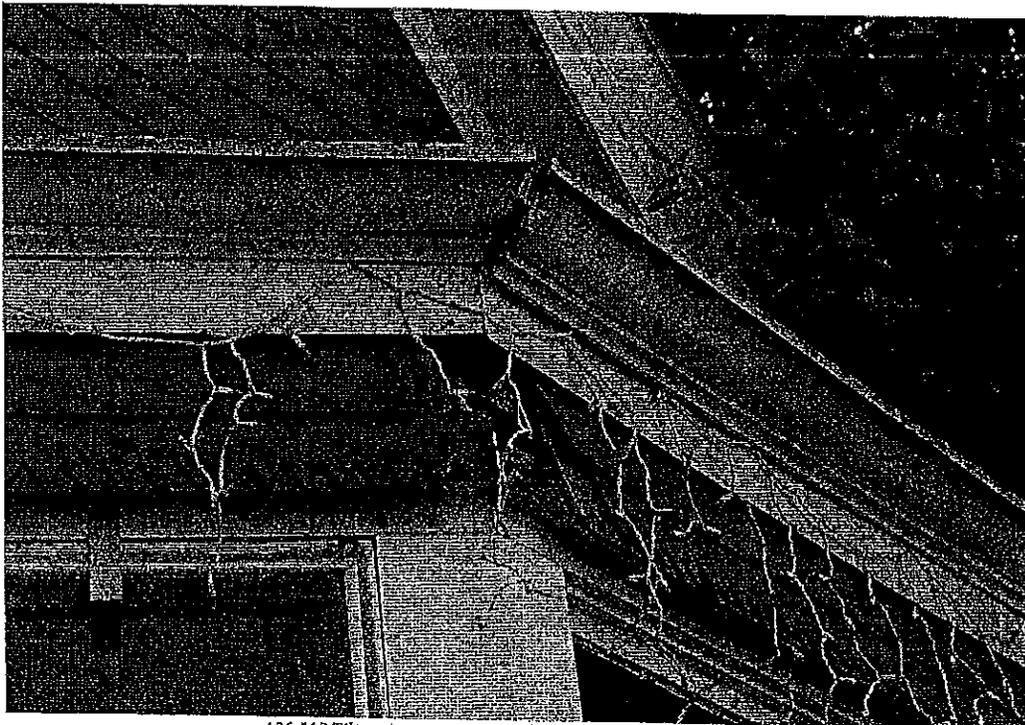
Since ARG's initial investigation in 2006, the condition of the buildings at 106-110 Tilton Avenue has deteriorated. The most notable damage to the residence is visible along the gutters, where many areas

have rusted, bowed, or collapsed completely. There are also indications of wood damage, particularly around the deteriorated gutters. Additionally, shingles are missing from some parts of the exterior, most notably on the south elevation. The wood windows on the 1905 portion appear to be in good condition, with no obvious damage; the metal windows on the 1947 addition, however, exhibit visible rust damage. Overall, the duplex at 106-110 Tilton Avenue is in fair condition.

106-110 Tilton Avenue, gutter and wood damage, north elevation
(Architectural Resources Group, February 2014)

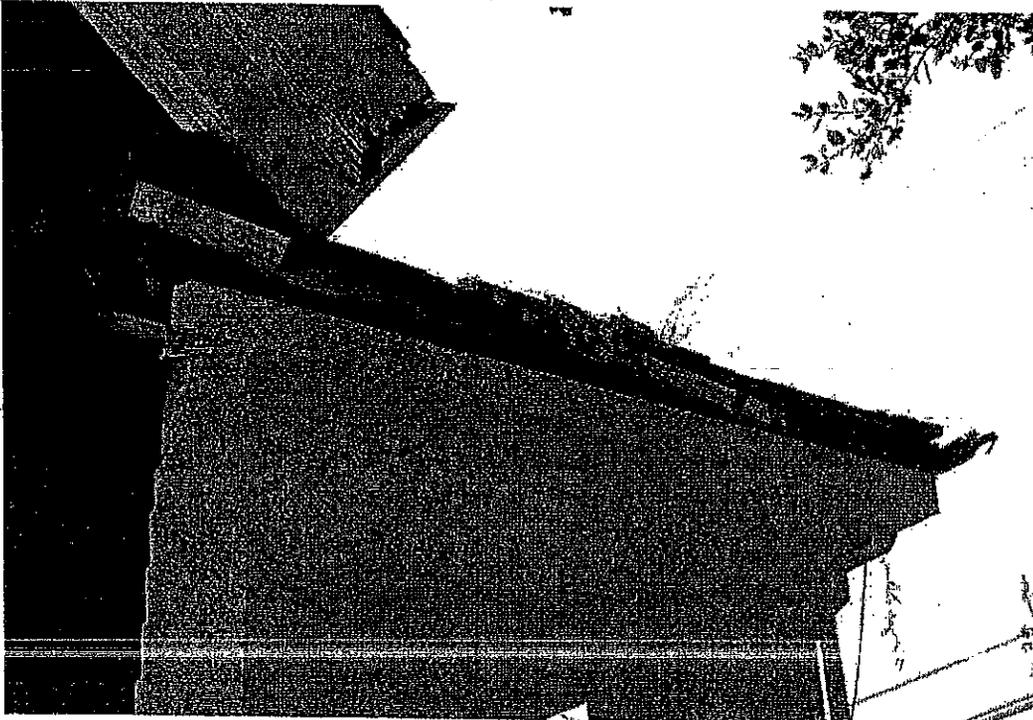
106-110 Tilton Avenue, gutter damage and wood deterioration, north elevation porch
(Architectural Resources Group, February 2014)

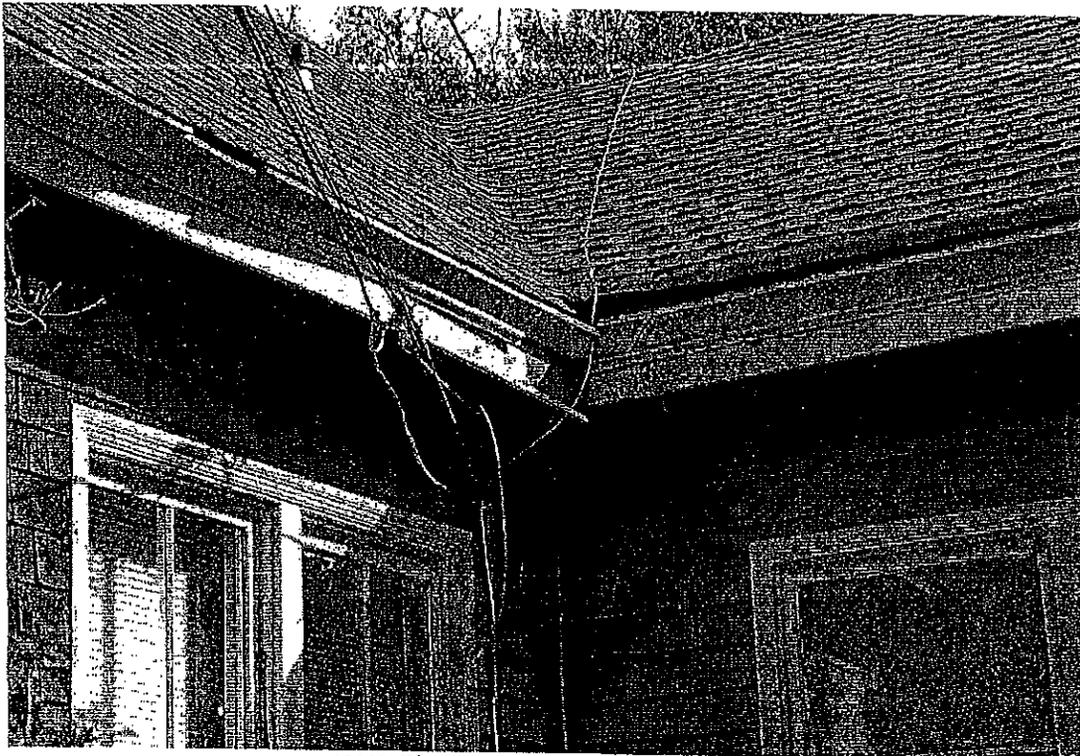
106-110 Tilton Avenue, gutter damage, north elevation
(Architectural Resources Group, February 2014)

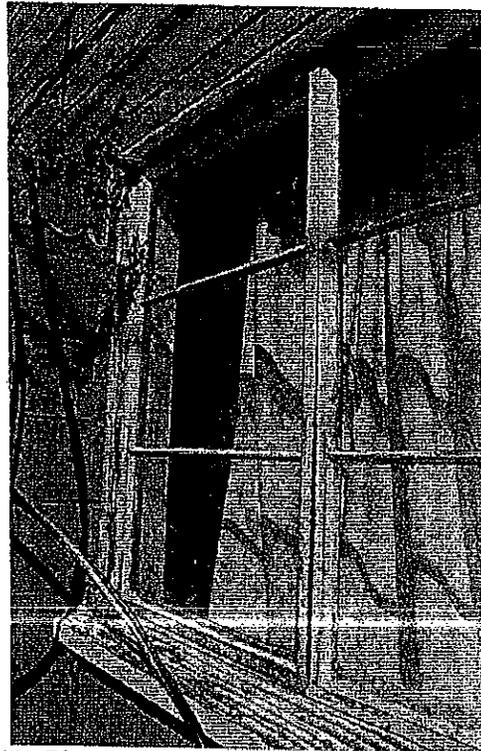
106-110 Tilton Avenue, rusted steel casement window, west elevation
(Architectural Resources Group, February 2014)

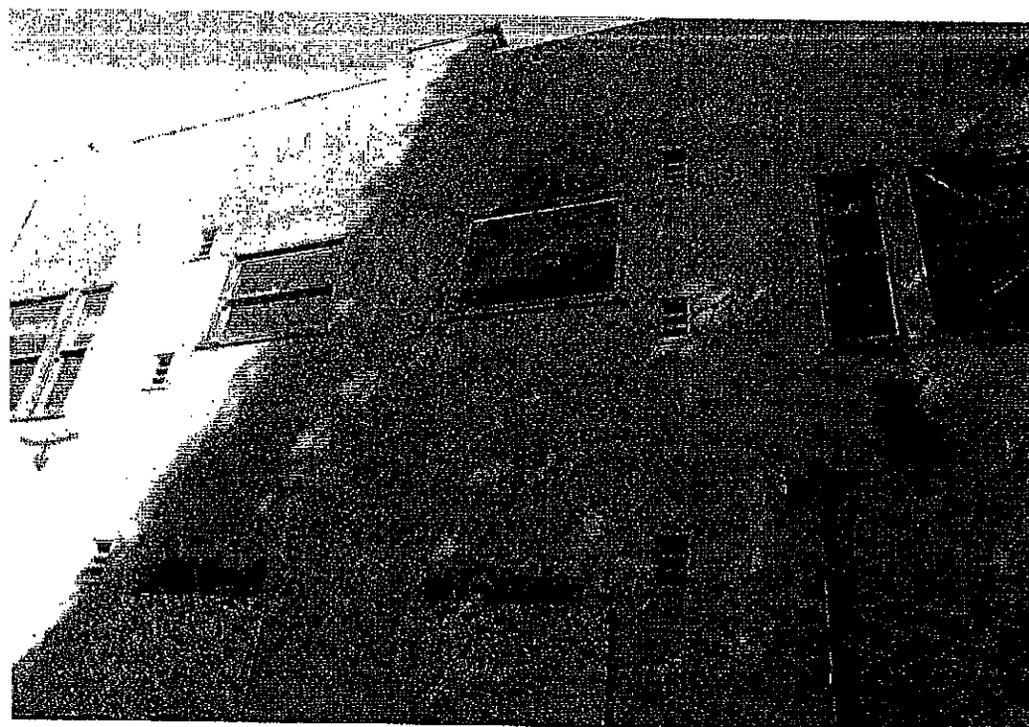
Like its neighbor, the apartment complex at 120 Tilton Avenue has deteriorated since ARG's evaluation in 2006. At some unknown date, a fire caused smoke damage, which is visible at the windows toward the rear of the west elevation.² There is significant bowing and cracking at the base of the building along the west elevation, and to a lesser degree along the east, likely caused by water damage.³ Less severe cracks appear throughout the building's exterior stucco cladding. Many windows and entrances are boarded up, so ARG was unable to assess their condition. Those that are visible, however, appear to be in fair to poor condition. Overall, the apartment building at 120 Tilton Avenue is in poor condition.

² ARG was unable to find information regarding the date or cause of the fire.

120 Tilton Avenue, fire damage, west elevation
(Architectural Resources Group, February 2014)

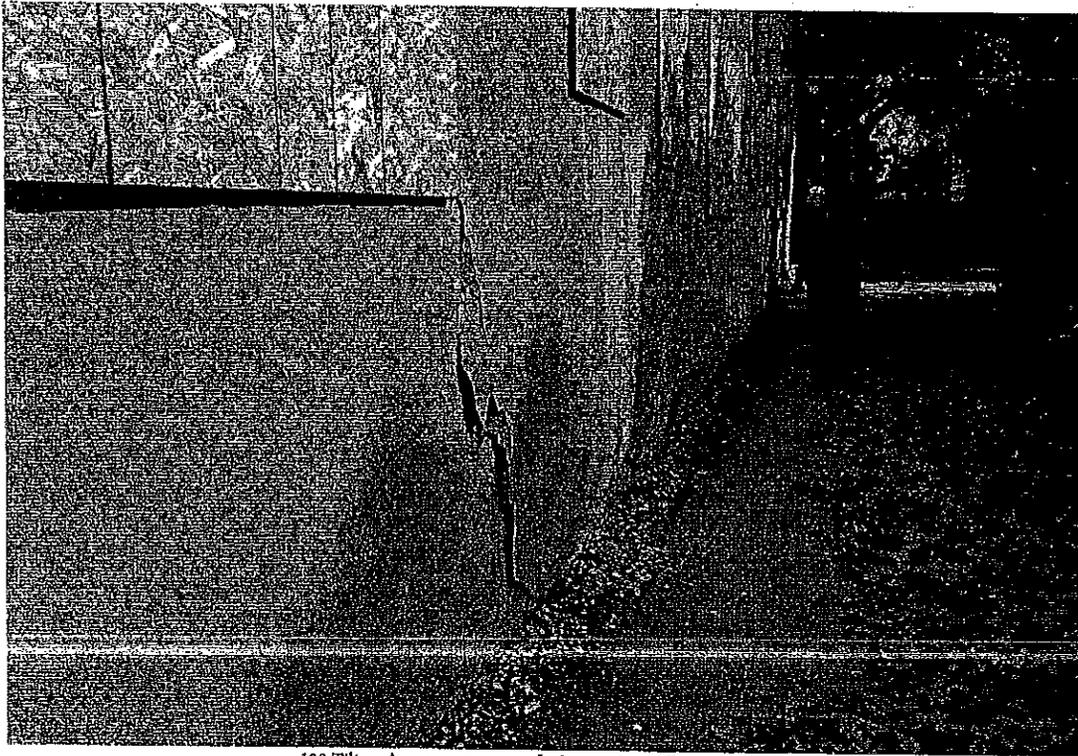
120 Tilton Avenue, severe cracks in exterior wall, west elevation
(Architectural Resources Group, February 2014)

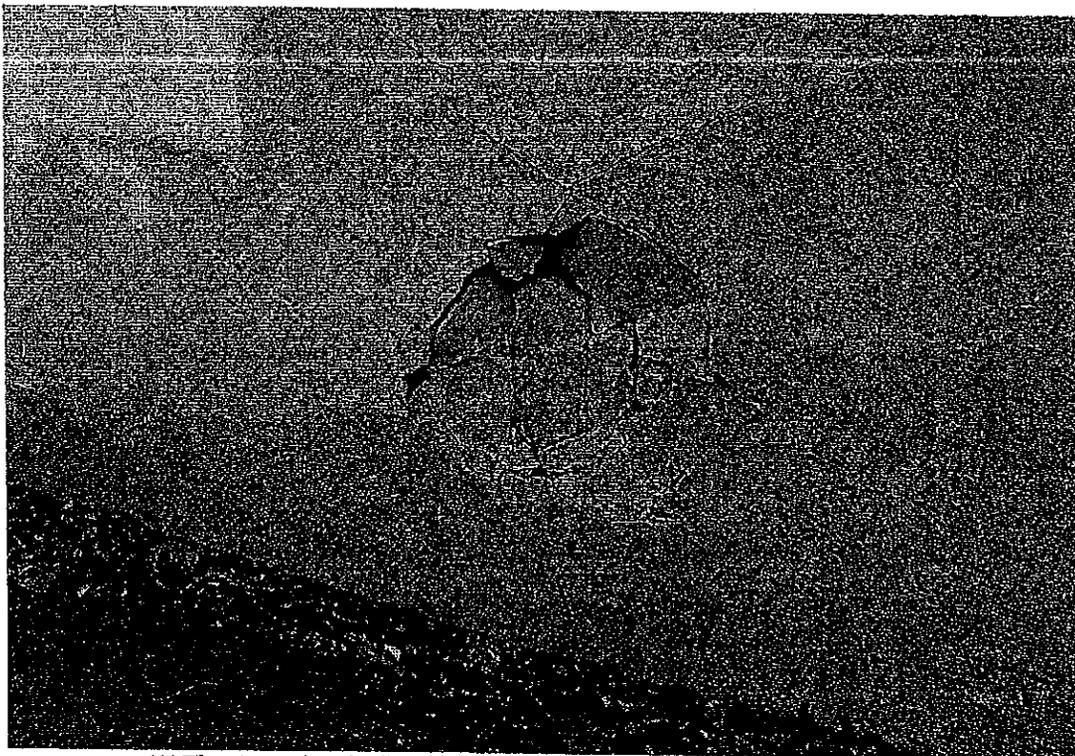
120 Tilton Avenue, bowed wall, impact damage, and severe cracking of stucco cladding, west elevation
(Architectural Resources Group, February 2014)

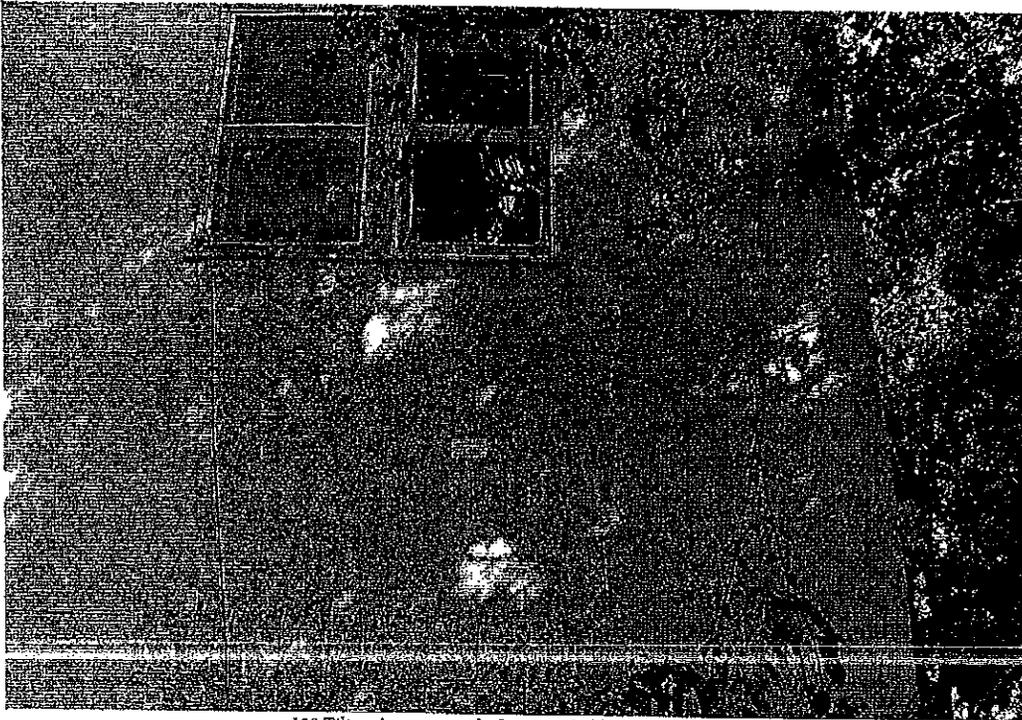
120 Tilton Avenue, cracked stucco cladding, west elevation
(Architectural Resources Group, February 2014)

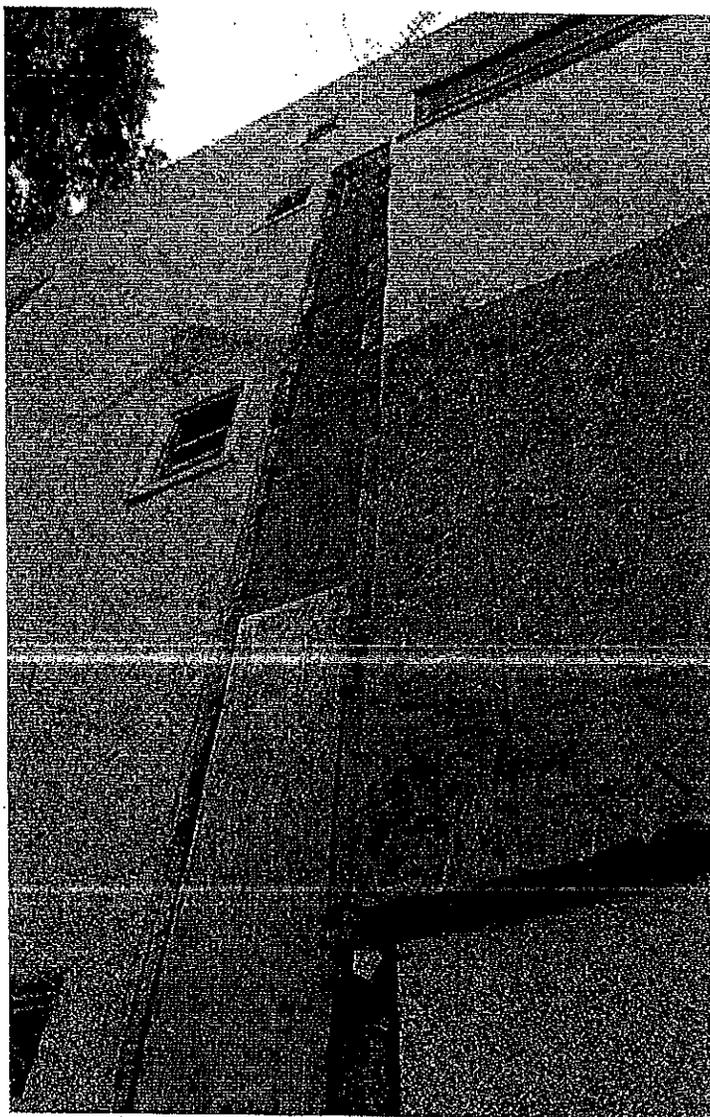
120 Tilton Avenue, section of removed stucco, east elevation
(Architectural Resources Group, February 2014)
