## Memorandum

Subject: Root Exploration at Central Park, San Mateo

Date: March 11, 2015

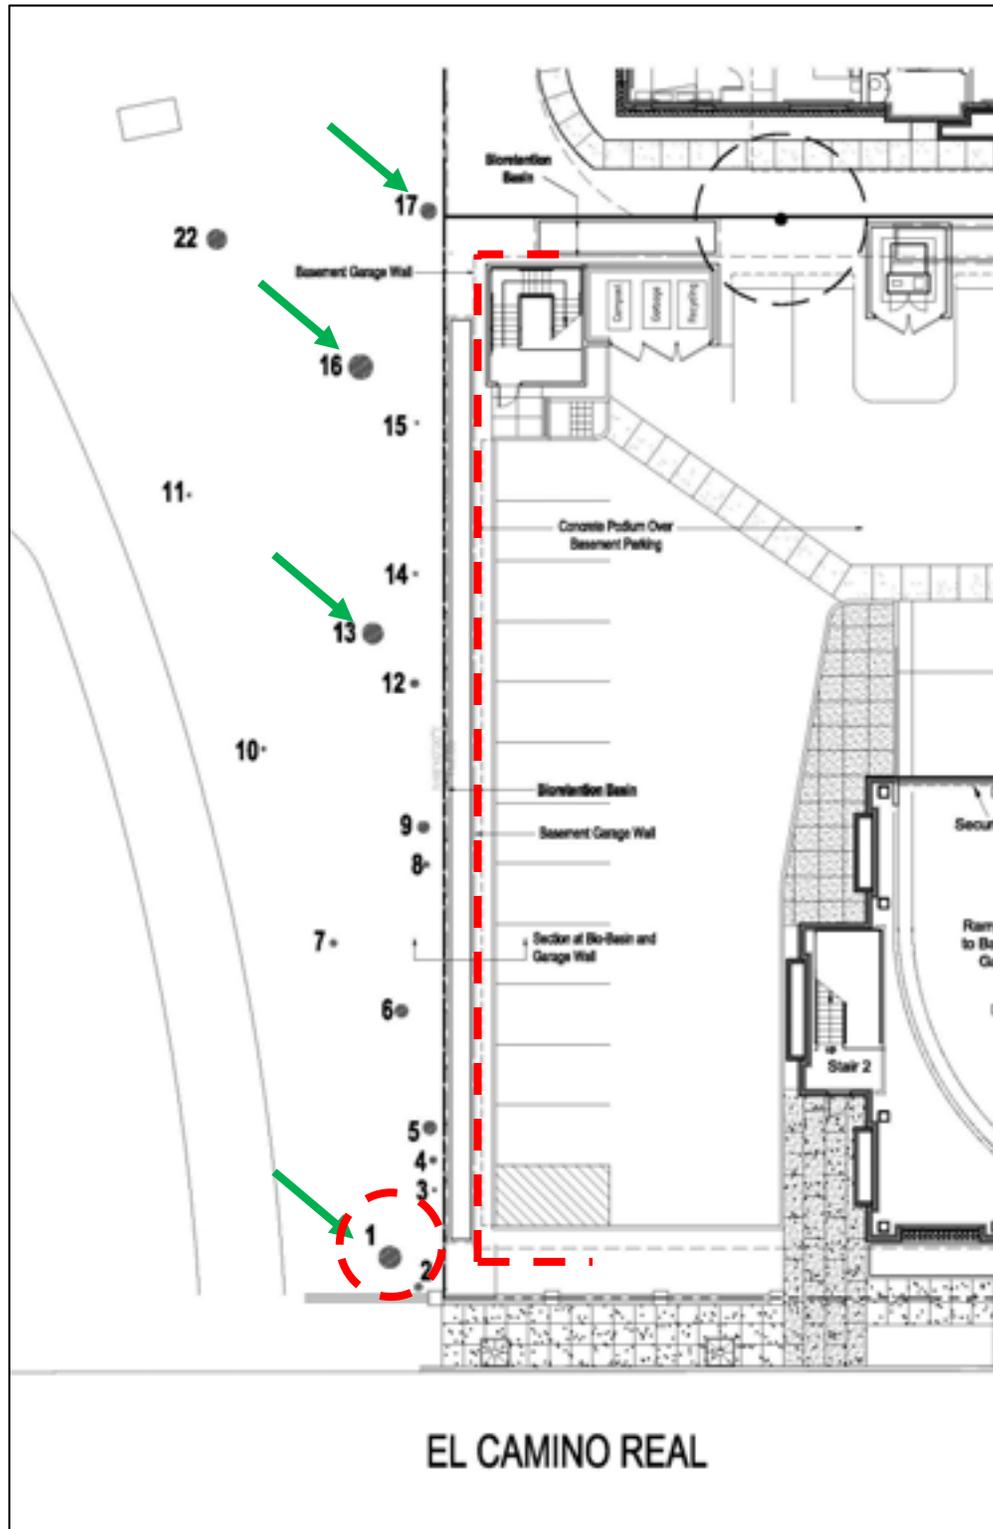
# Exhibit 1

Figure 1: locations of the subject trees, indicated by green arrows, and the extent of the root exploration and root crown excavation, indicated as red dashed lines.
