March 16, 2011

**RE: Saint Matthew Parish Gymnasium**

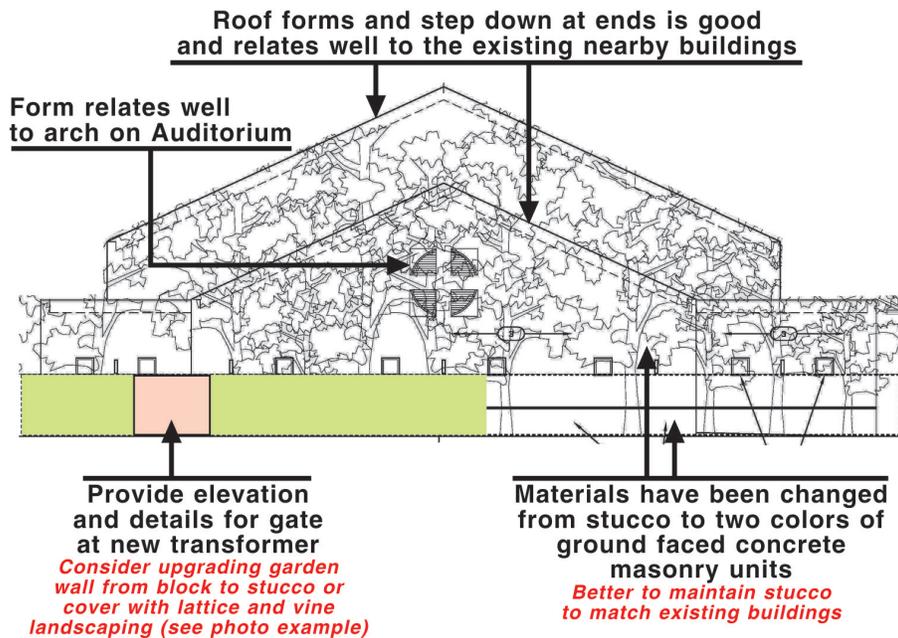
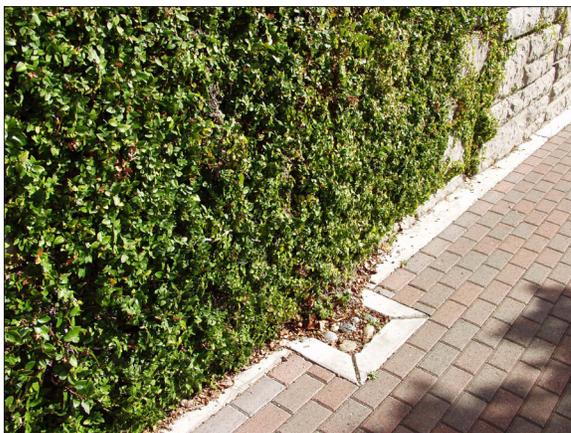
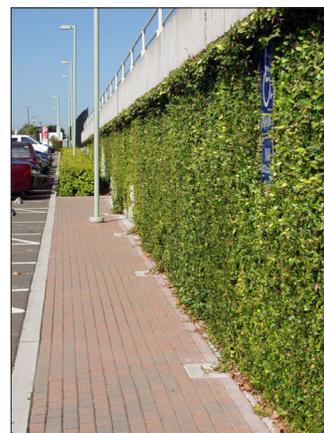
3. The existing garden wall along the El Camino Real property line is proposed to remain. The wall is not currently very attractive, and tends to negatively impact the otherwise strong visual quality of the Auditorium and El Camino Real streetscape. It would be desirable to finish this wall with stucco to match the existing buildings and the new structure. Alternatively, vine landscaping could be installed over the existing wall. One example is shown in the photos below.

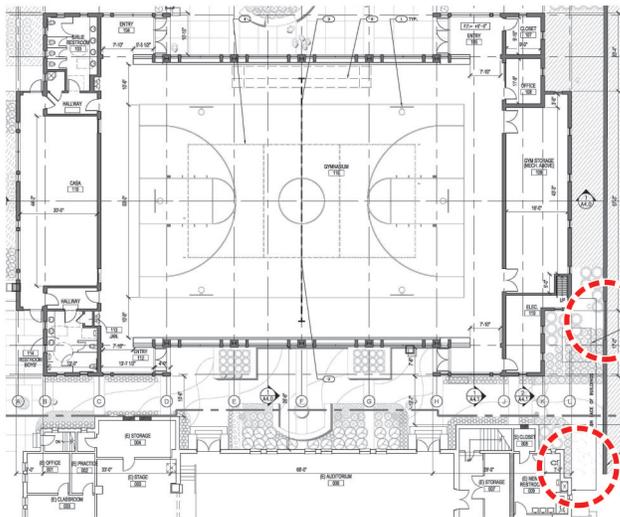
4. There is currently a rather unattractive chain link gate located at the juncture of the above referenced garden wall with the Auditorium (see photo to the right). It would be desirable, as part of this project, to eliminate, relocate, or replace this gate with a more attractive gate more in keeping with the design and character of the buildings.

Current location of unattractive chain link gate - Will it be removed or replaced?
