Tree Protection Plan

Hillsdale Shopping Center
North Block Reconfiguration
San Mateo, CA

March 2015

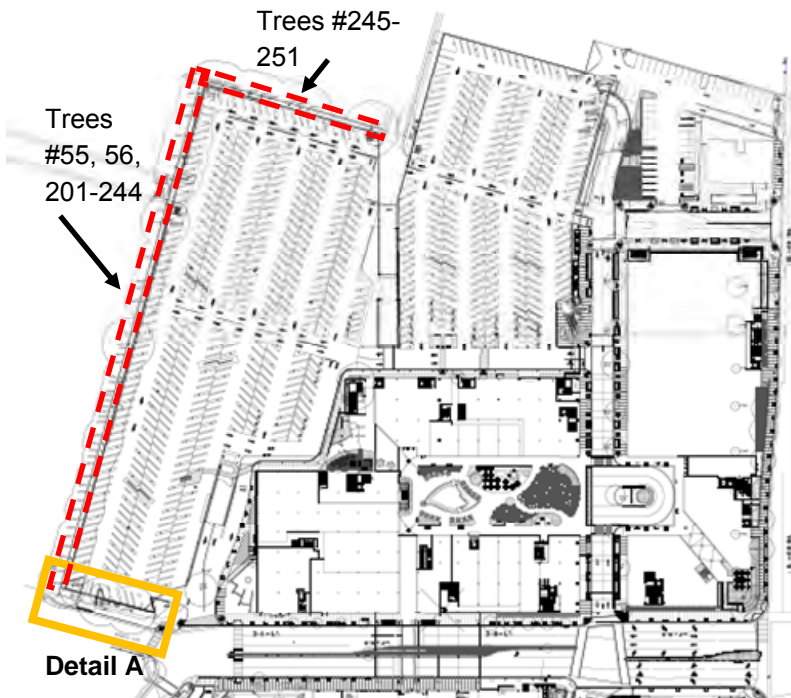
Detail A

Tree Protection Zone
No grading, excavation, construction, storage, dumping or trenching in this area. Enclose with 6' chain-link fence.

1. Fence trees #53, 54 and 57 to enclose the **TREE PROTECTION ZONE** prior to demolition, grubbing or grading. Fences shall be 6 ft. chain link with posts sunk into the ground. Fences are to remain until all grading and construction is completed.
2. Silver dollar gum trees #55, 56, 201-251 are adequately protected by the parking structure and do not require protective fencing.
3. Prior to issuance of demolition permits, the Project Arborist is to submit a letter including photos by fax or email to the City Arborist verifying that all tree protection measures are properly implemented and clearance pruning of the trees has been completed.
