RE: Building Survey Summary
Leong Family Dentistry
420 Peninsula Avenue
San Mateo, CA 94401

BUILDING CONDITION SURVEY REPORT

**PENINSULA HEALTH CENTER
420 PENINSULA AVENUE
SAN MATEO, CA**

PROFESSIONAL OFFICE CONDOMINIUM CONVERSION

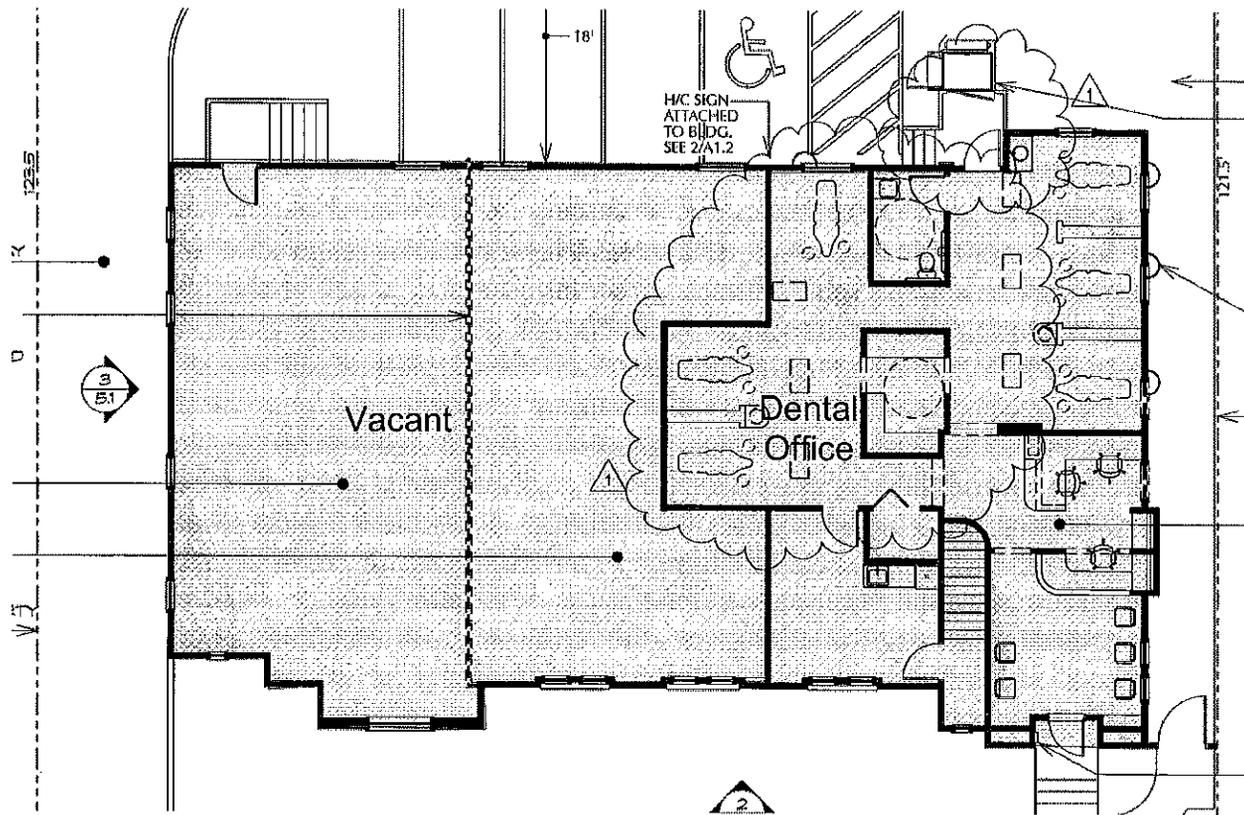
Figure 1 Building Floor Plan

The building was originally constructed in the 1920s. It is a one-story, type V non-rated building with a total area of 3,396 square feet. The building has been owned by Mr. Leong since 2003. In 2005, a portion of the building (1,471 square feet) was renovated to be used as Leong Dentistry's office. At the time of this survey, the remaining 1,925 square feet of space remained vacant (see Figure 1). According to the building owner, the vacant space will be renovated to office space.
