Tree Protection Plan

Hillsdale Shopping Center
North Block Reconfiguration
San Mateo, CA

March 2015

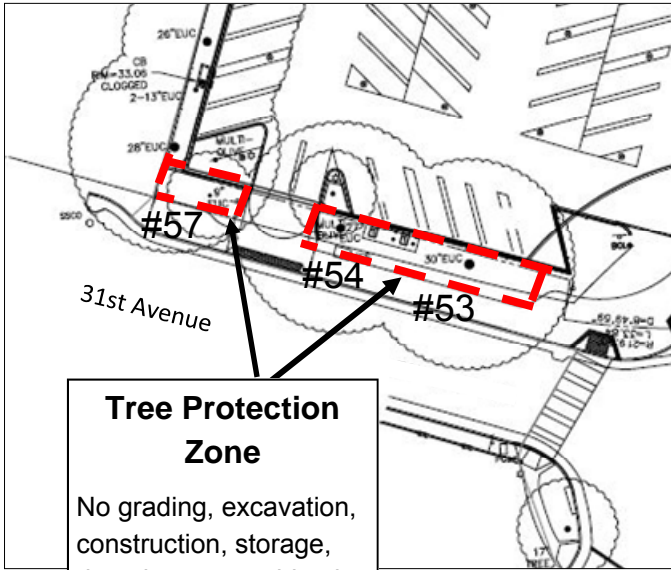
Detail A

Tree Protection Zone
No grading, excavation, construction, storage, dumping or trenching in this area. Enclose with 6' chain-link fence.

Tree #	Species	Trunk Diameter
53*	Silver dollar gum	38"
54*	Silver dollar gum	28"
57	Silver dollar gum	8"

*Heritage Tree

1. Fence trees #53, 54 and 57 to enclose the **TREE PROTECTION ZONE** prior to demolition, grubbing or grading. Fences shall be 6 ft. chain link with posts sunk into the ground. Fences are to remain until all grading and construction is completed.
2. Silver dollar gum trees #55, 56, 201-251 are adequately protected by the parking structure and do not require protective fencing.
3. Prior to issuance of demolition permits, the Project Arborist is to submit a letter including photos by fax or email to the City Arborist verifying that all tree protection measures are properly implemented and clearance pruning of the trees has been completed.
